JOHN WAYNE MARINA – Property Condition Assessment

March 2019

Reid Middleton

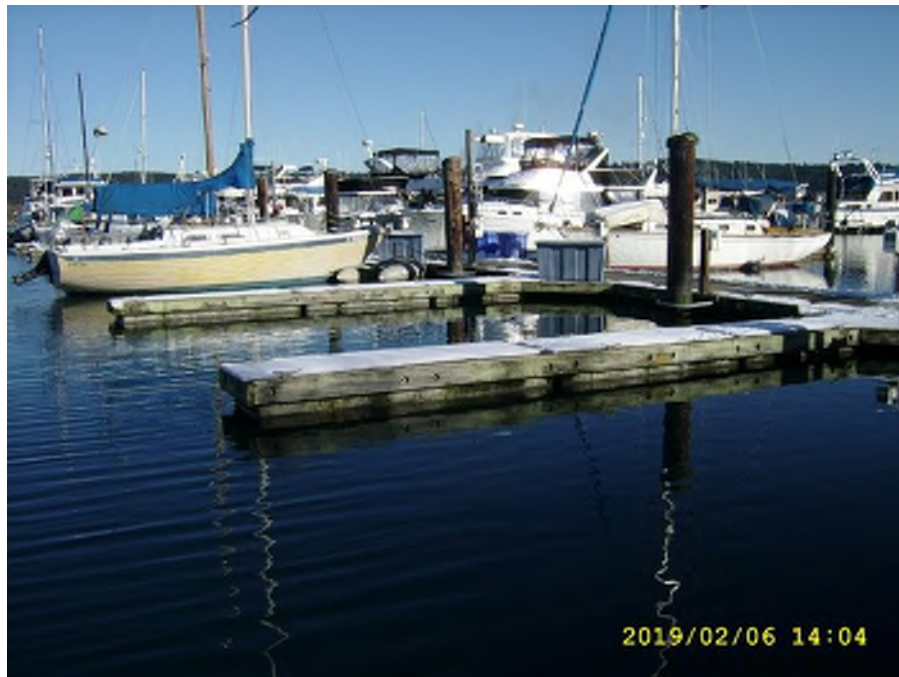
Figure 11. Float C/D – Typical Finger Condition

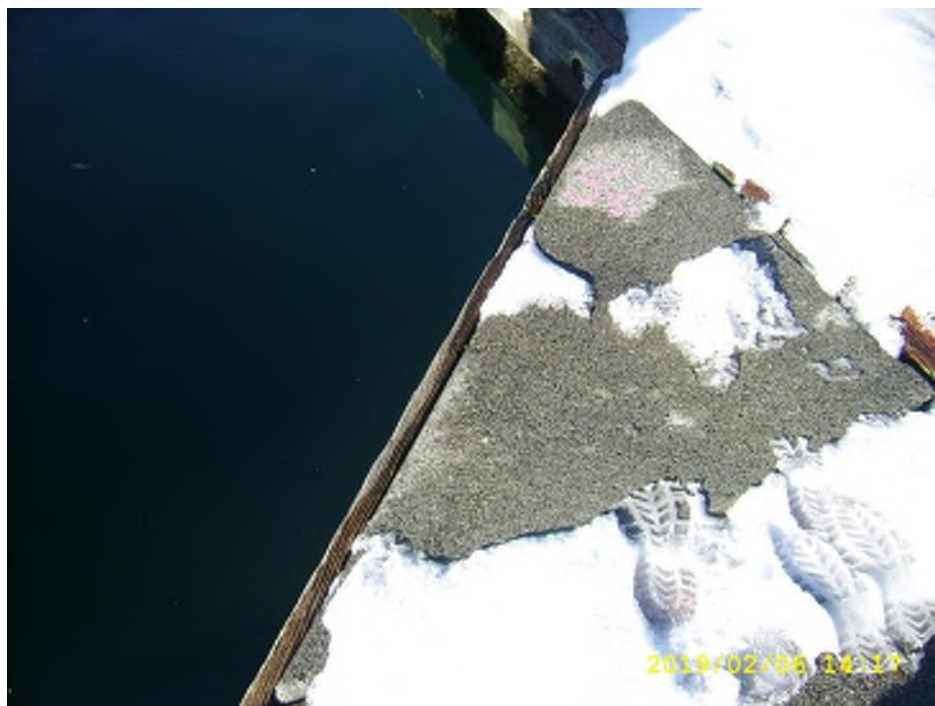
Figure 12. Float C/D – Typical Damaged Concrete Tri-Frame

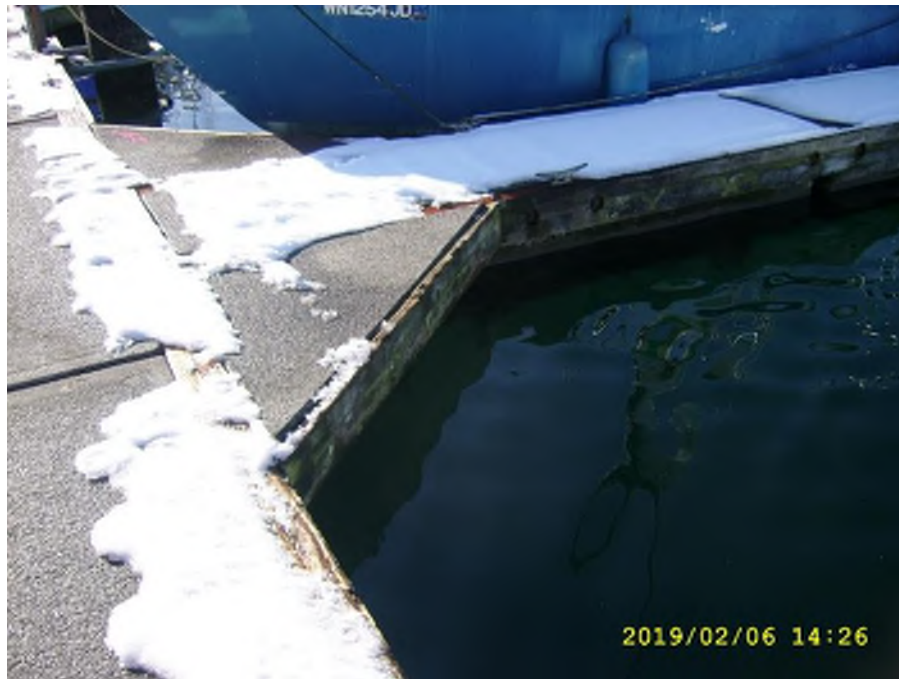
Figure 13. Floats B/C/D – Typical Deteriorated Rub Boards

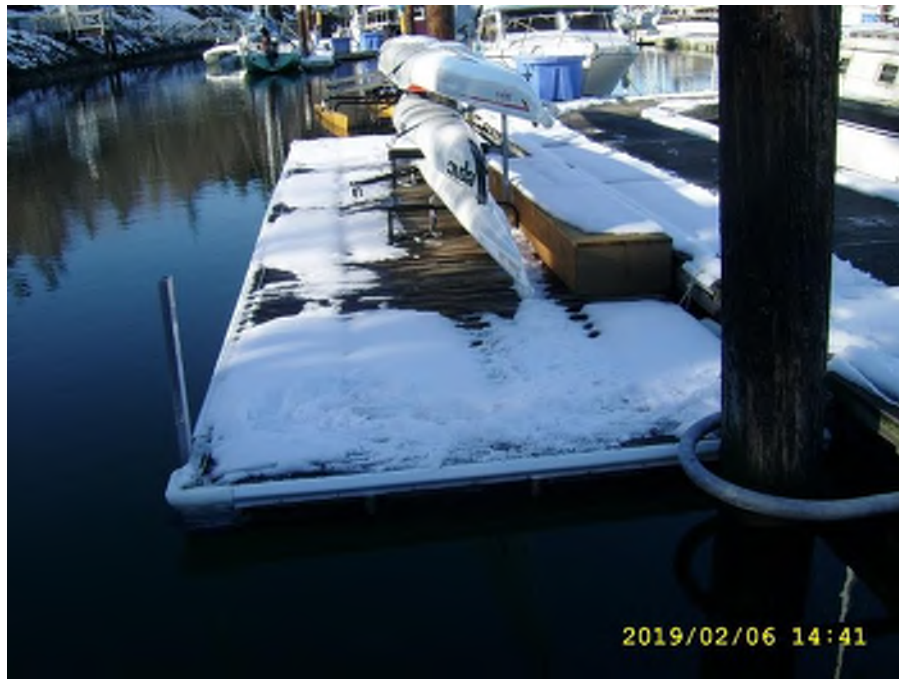
Figure 15. Float B/C/D – Kayak Float

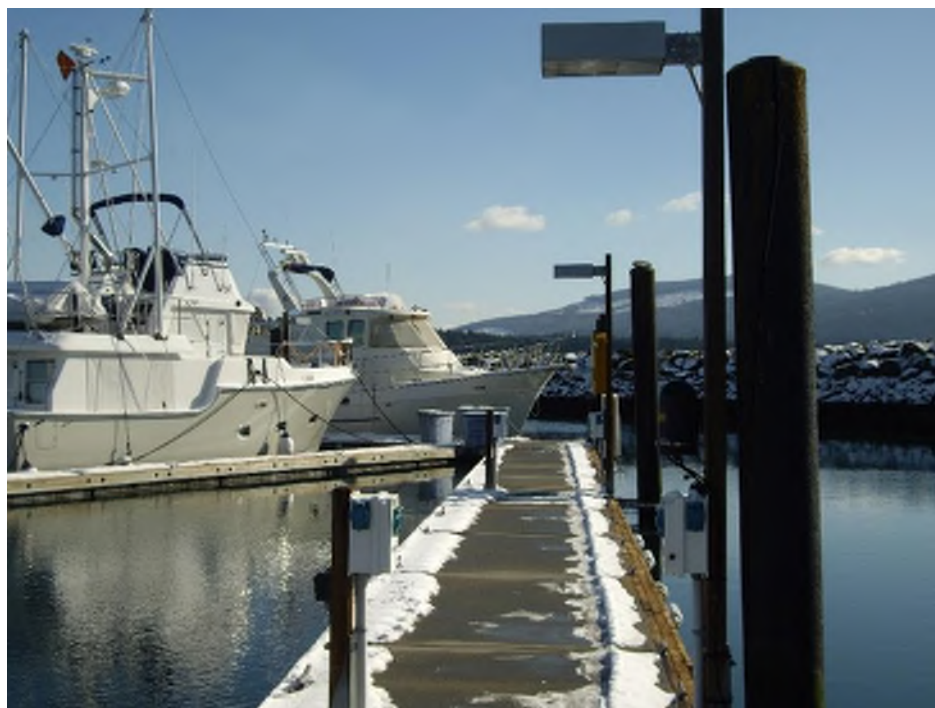
Figure 16. Float B – Typical Plastic Pile Condition. Note Pile Caps Open.

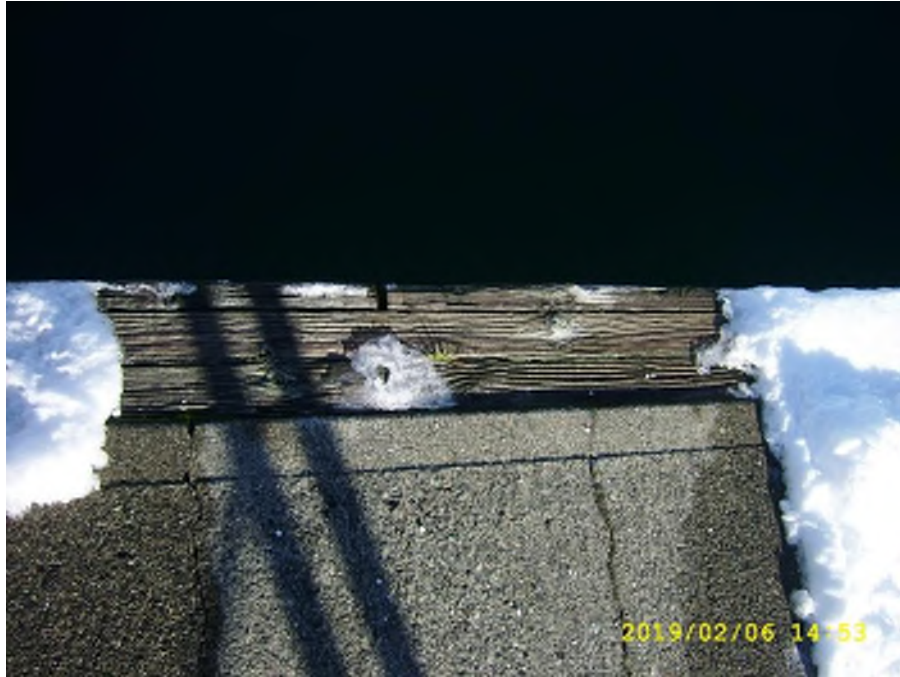
Figure 19. Floats E/F – Typical Float Cracking and Waler / Rub Board Deterioration

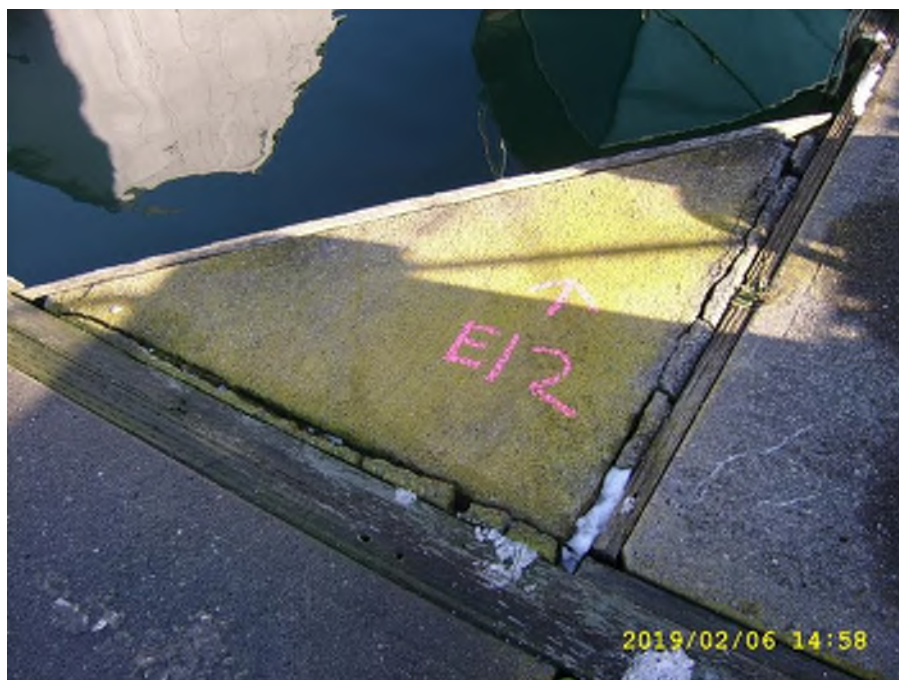
Figure 21. Floats E/F – Concrete Tri-Frame Damage

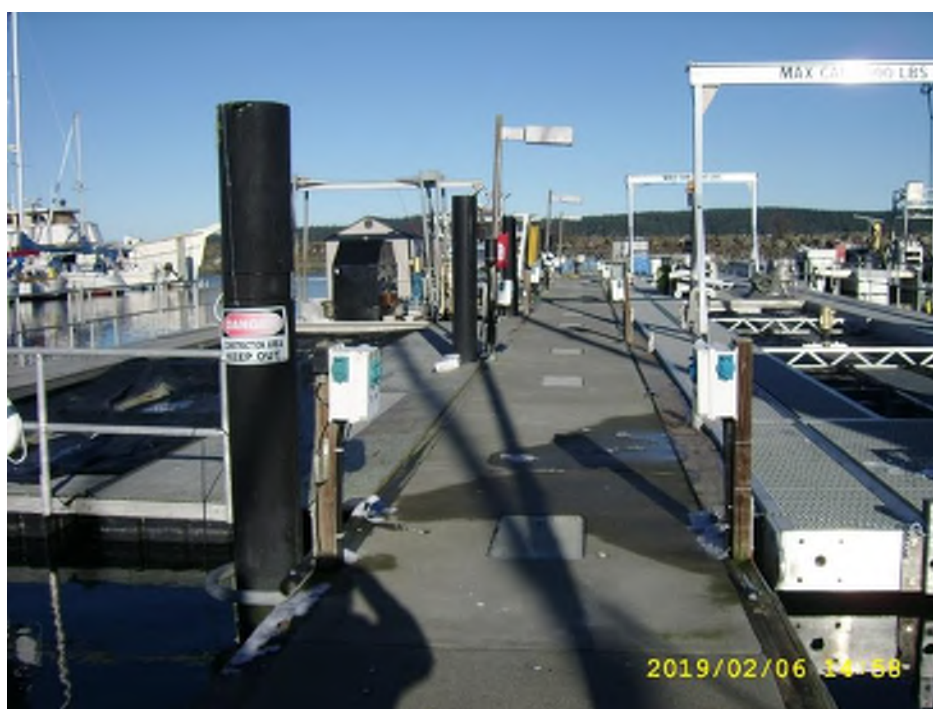
Figure 22. Float E – Typical Plastic Pile Condition

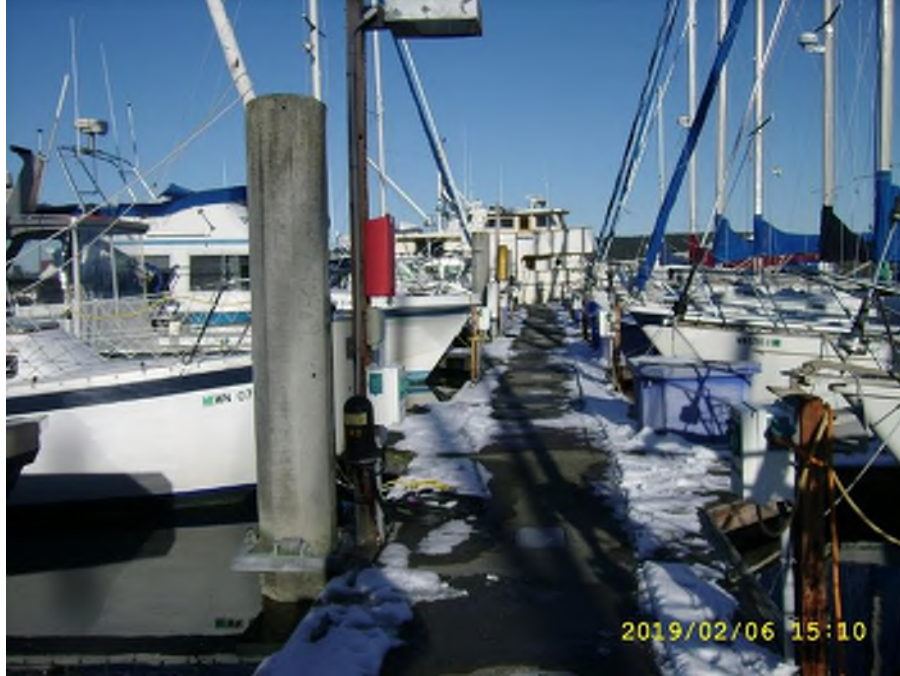
Figure 23. Float F – Typical Concrete Pile Condition

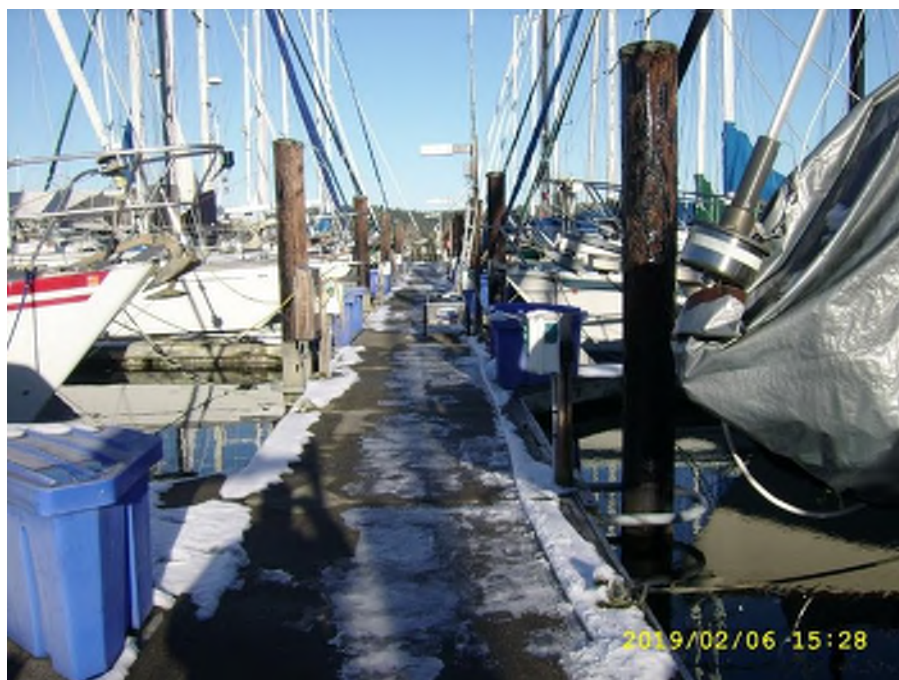
Figure 25. Floats G/H Typical Condition

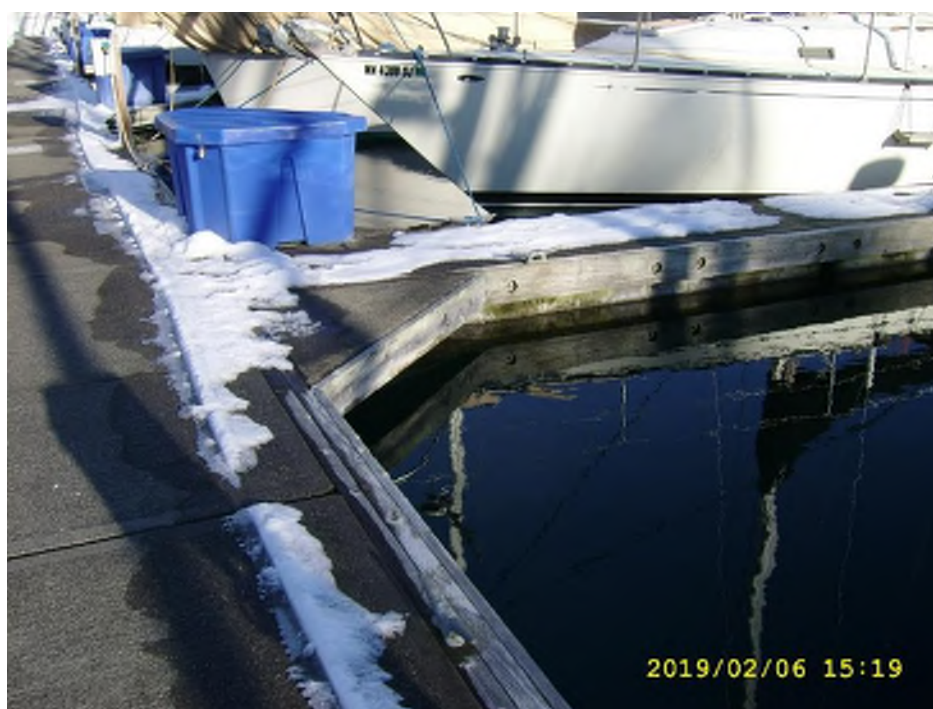
Figure 26. Floats G/H – Typical Concrete and Water Condition

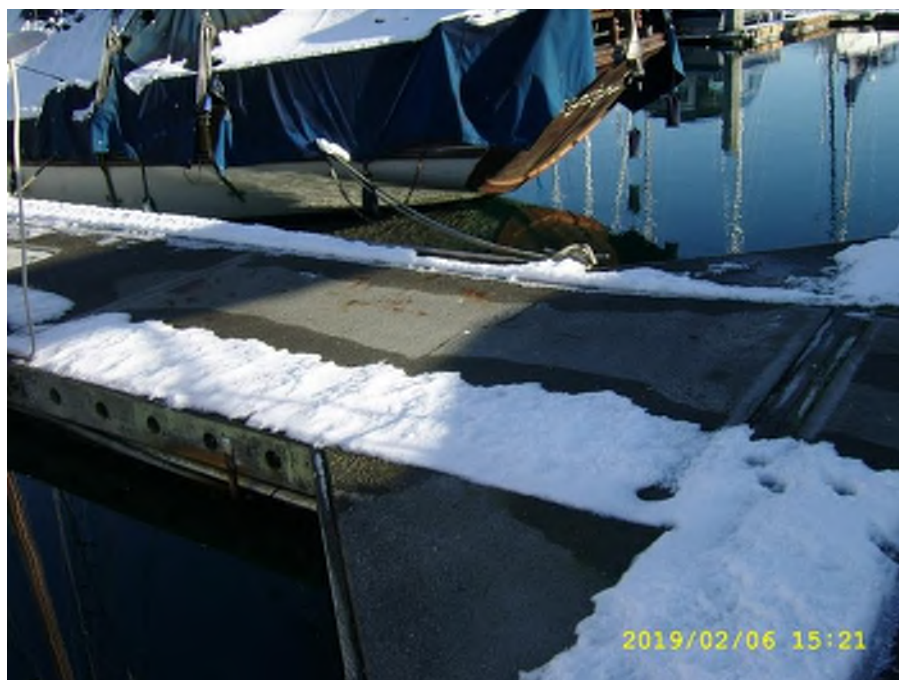
Figure 27. Floats G/H – Rust Staining on Concrete Floats

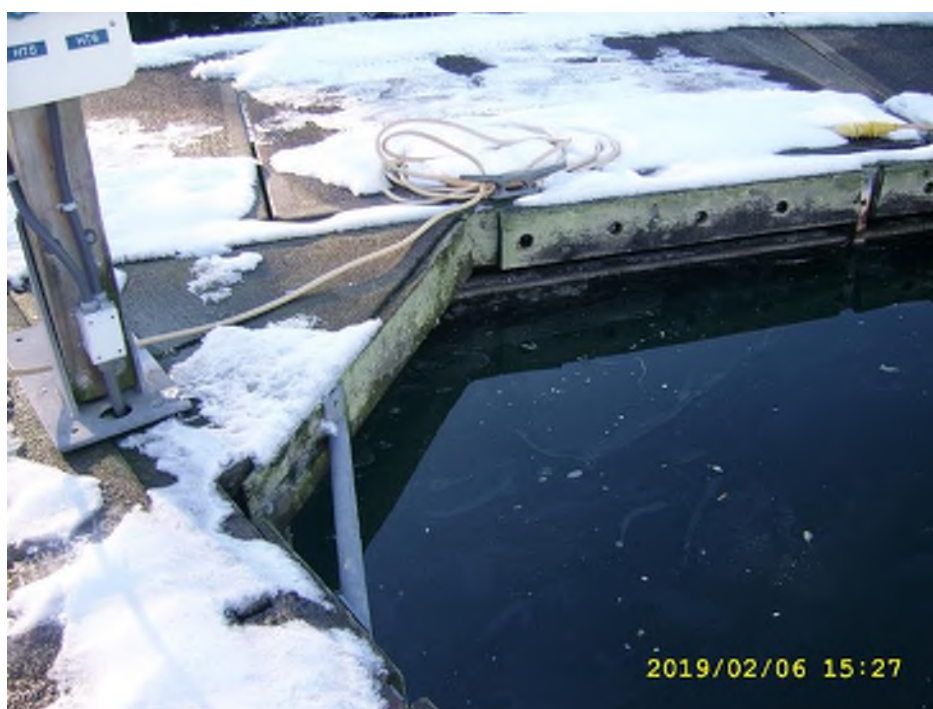
Figure 28. Floats E/F – Typical Deteriorated Rub Boards

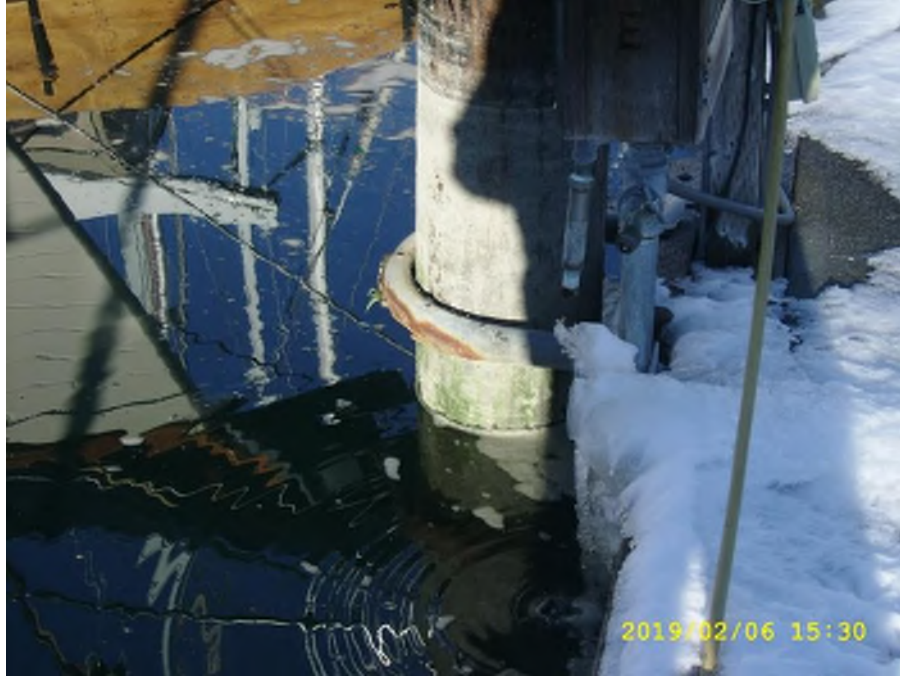
Figure 29. Floats G/H – Major Pile Hoop Corrosion

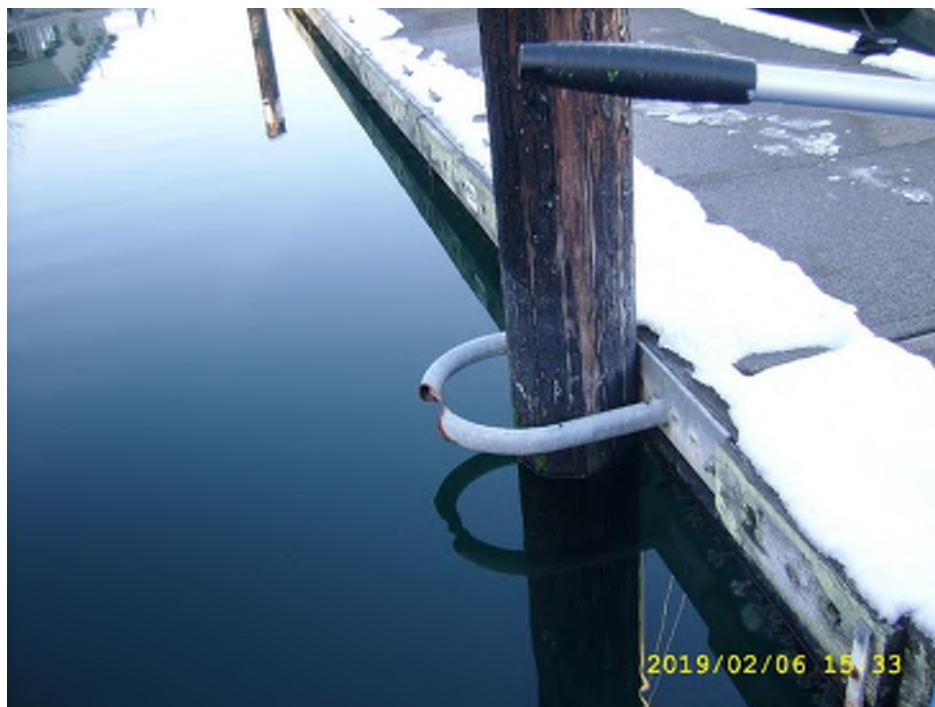
Figure 30. Floats G/H- Severe Pile Hoop Corrosion

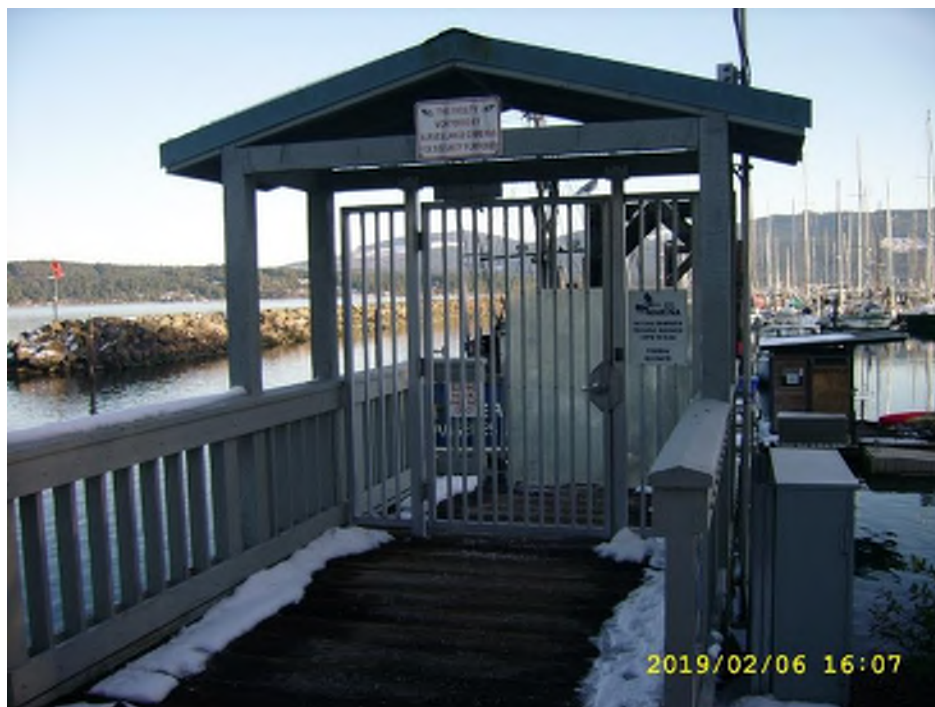
Figure 32. Guest Float – Pier & Gate Structure Condition

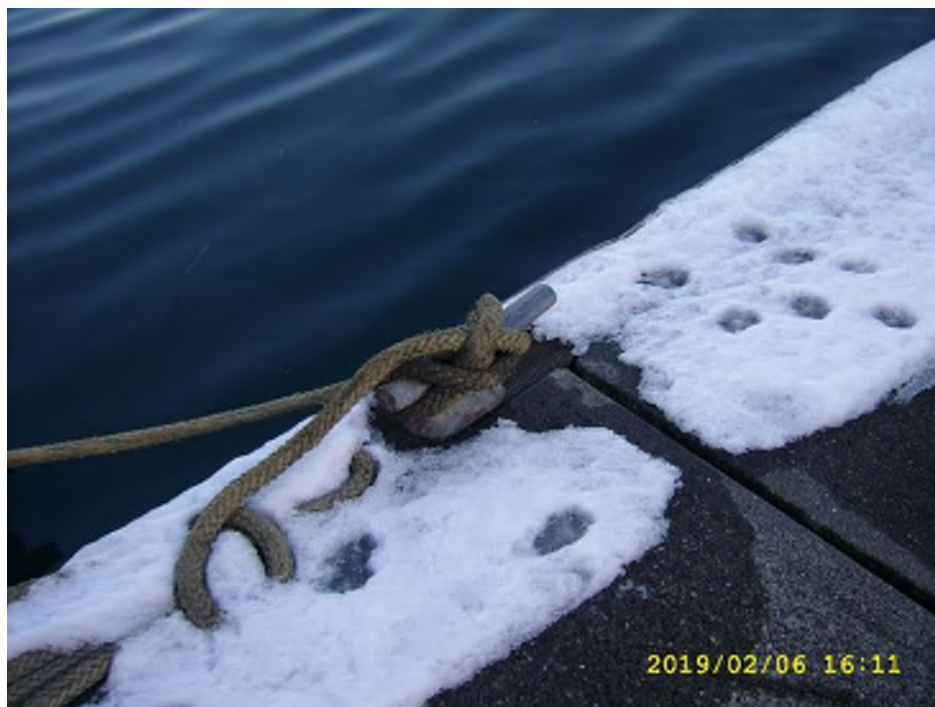
Figure 36. Guest Float – Broken 18 Inch Cleat

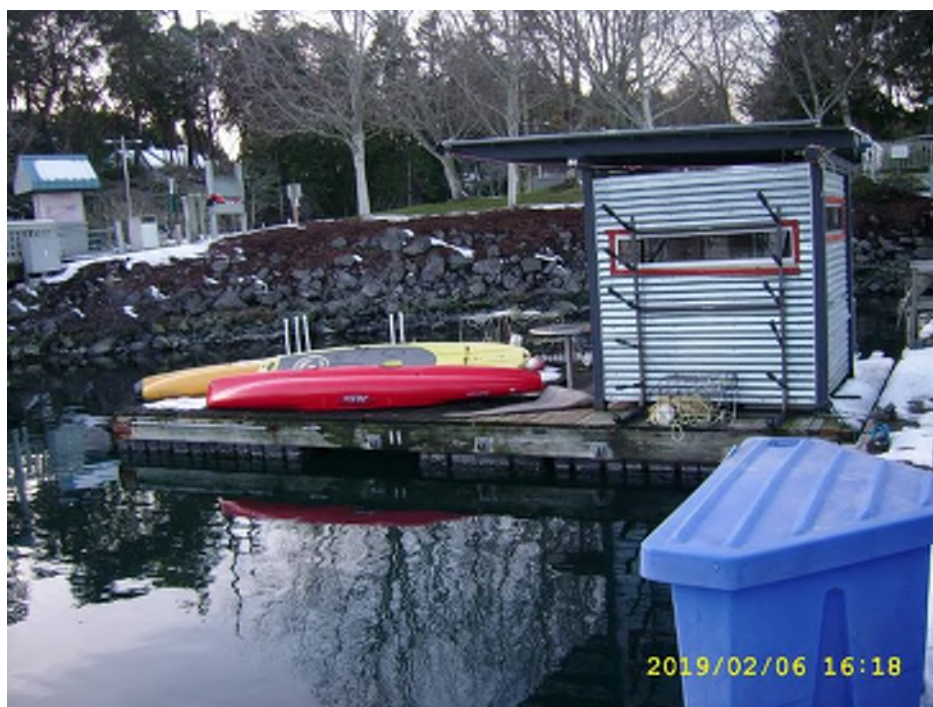
Figure 38. Guest Float – Kayak Float

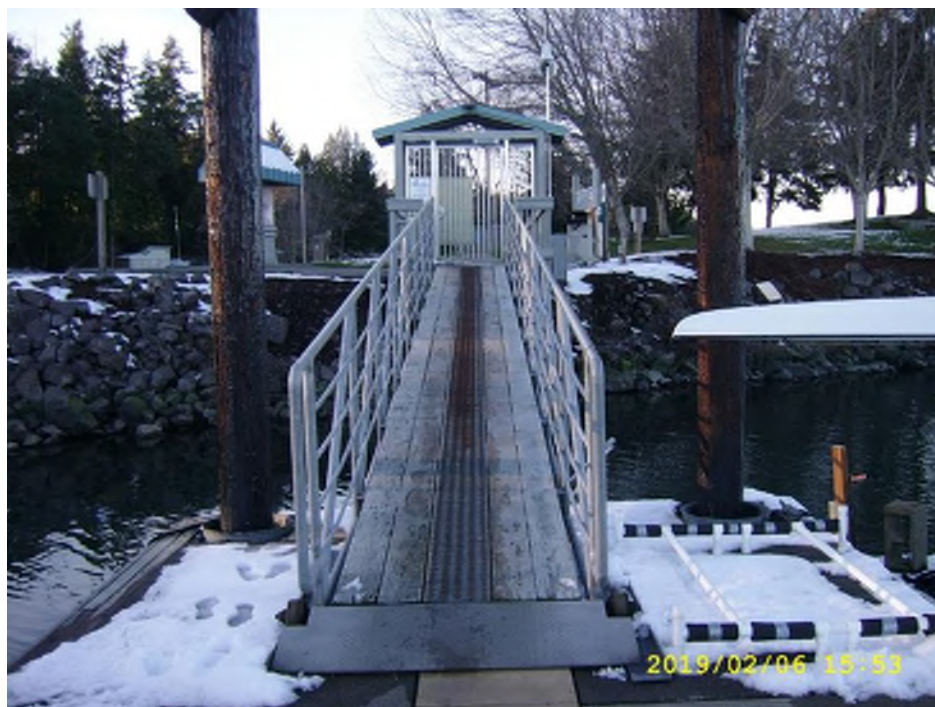
Figure 40. Fuel Float – Gangway Condition. Note Rusty Grating and Worn Non-Skid Coating.

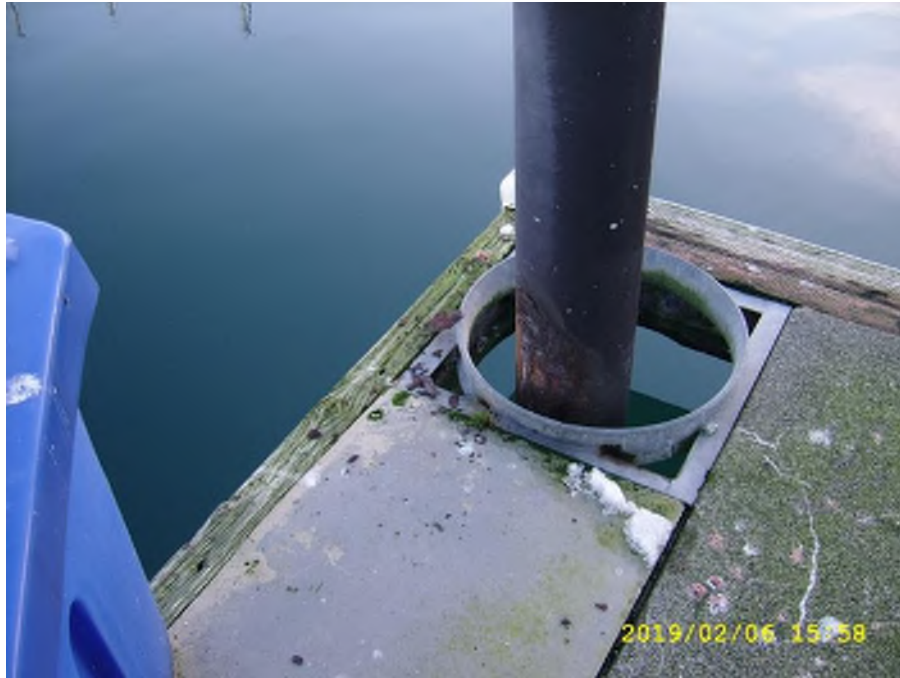
Figure 43. Fuel Float – Corroded Steel Pile at End of Float

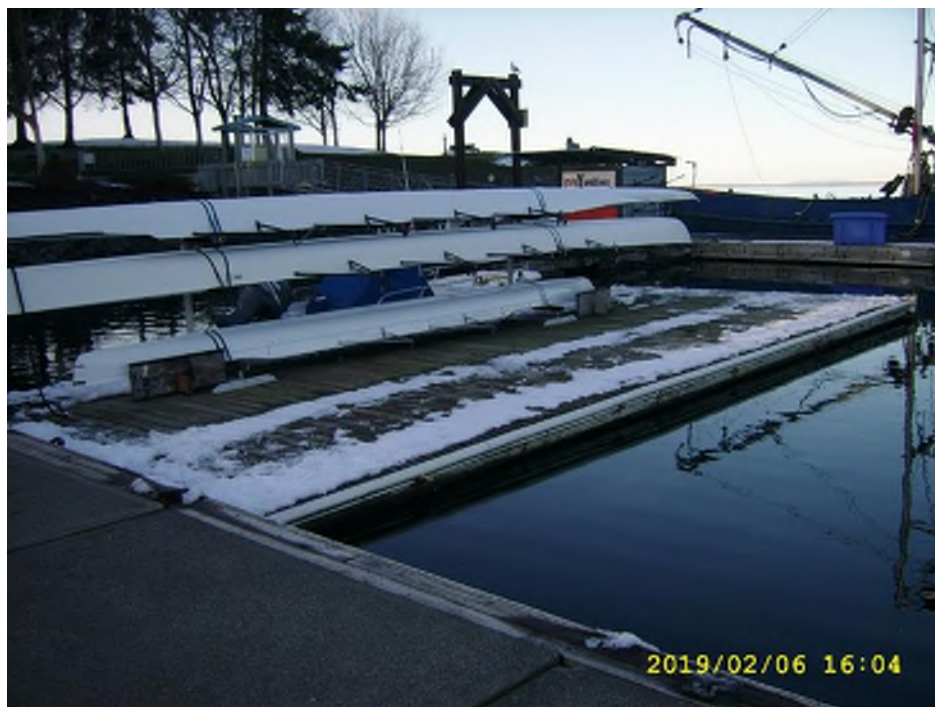
Figure 44. Fuel Float – Kayak Float

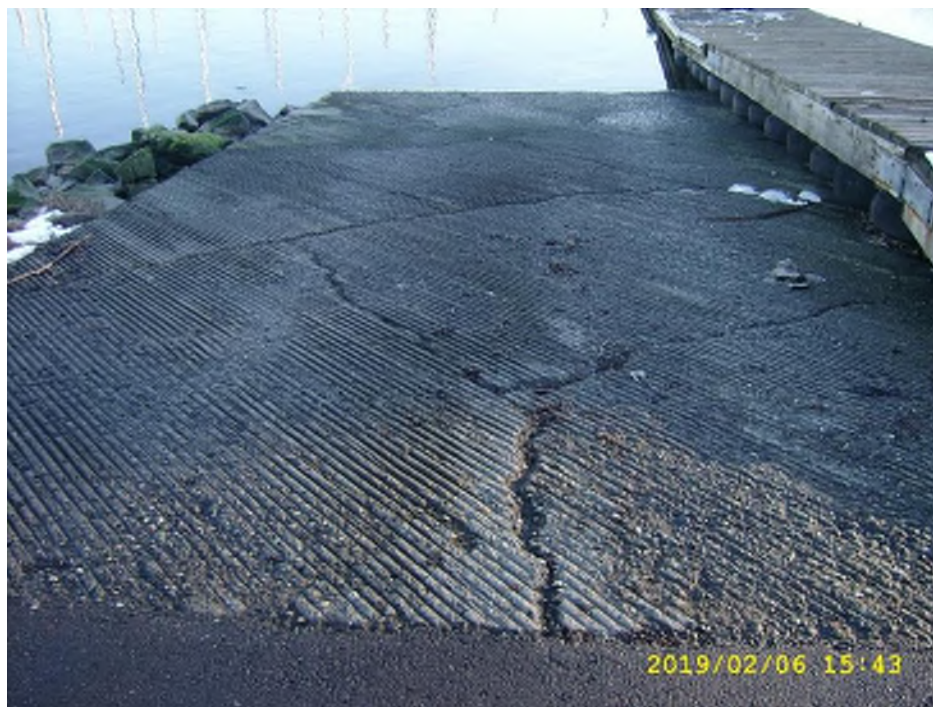
Figure 46. Boat Launch – Typical Concrete Ramp Cracking

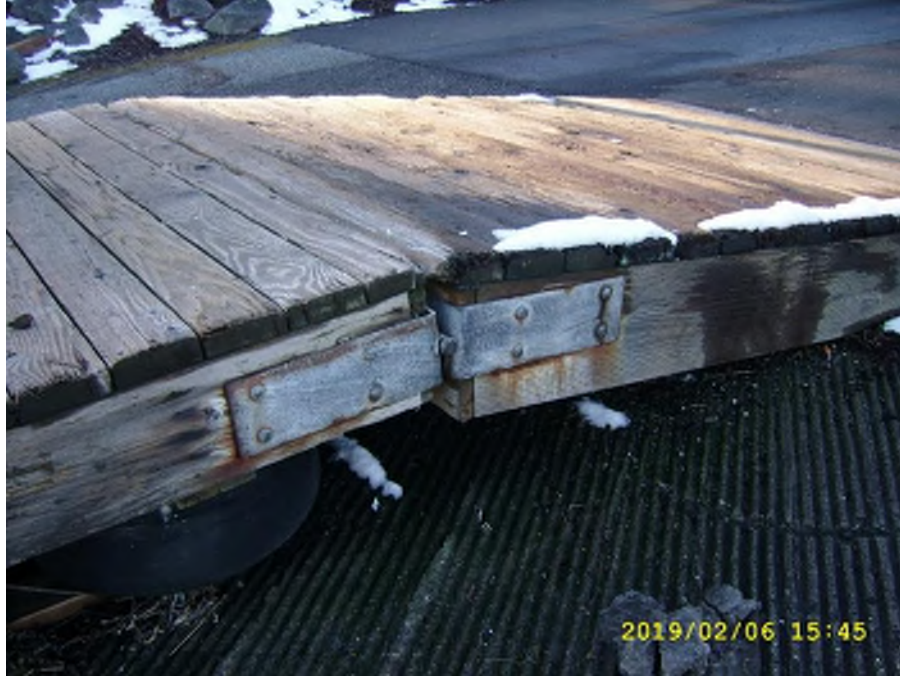
Figure 47. Boat Launch – Typical Worn Timber Decking and End Rot.

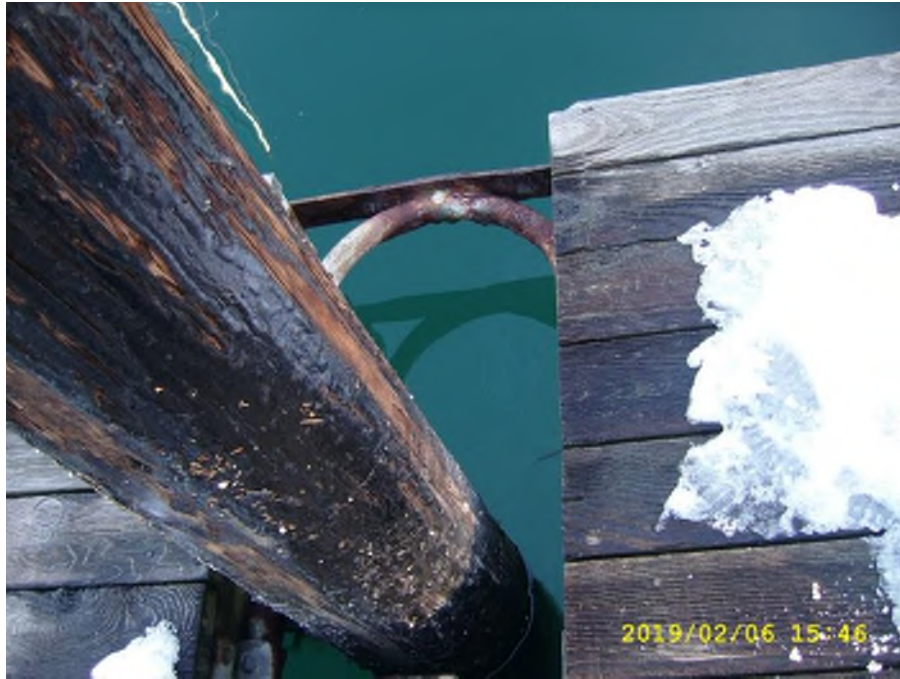
Figure 49. Boat Launch – Pile Hoop Typical Corrosion

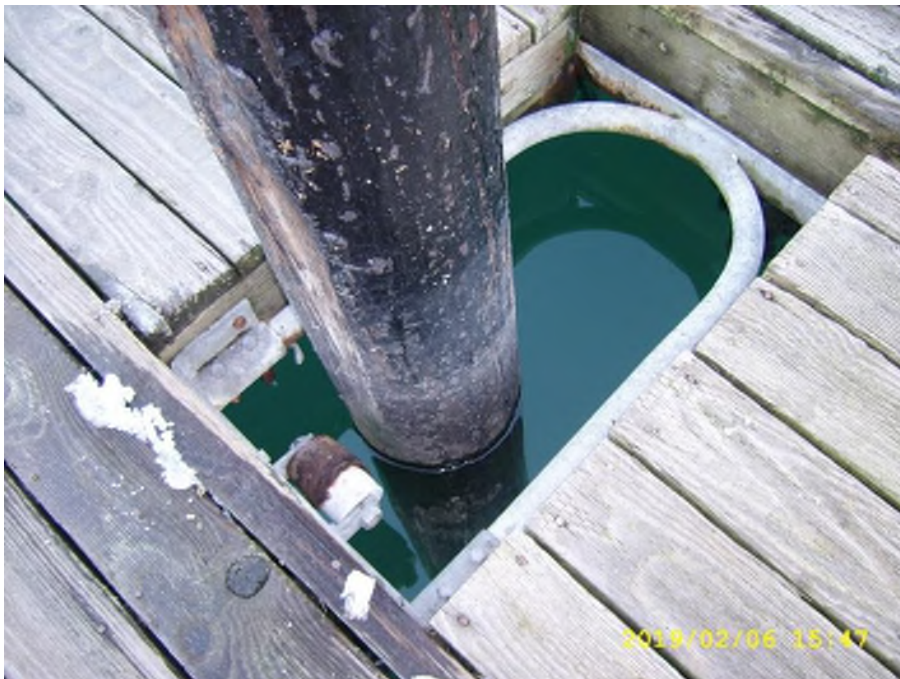
Figure 50. Boat Launch – Deteriorated Pile Rollers

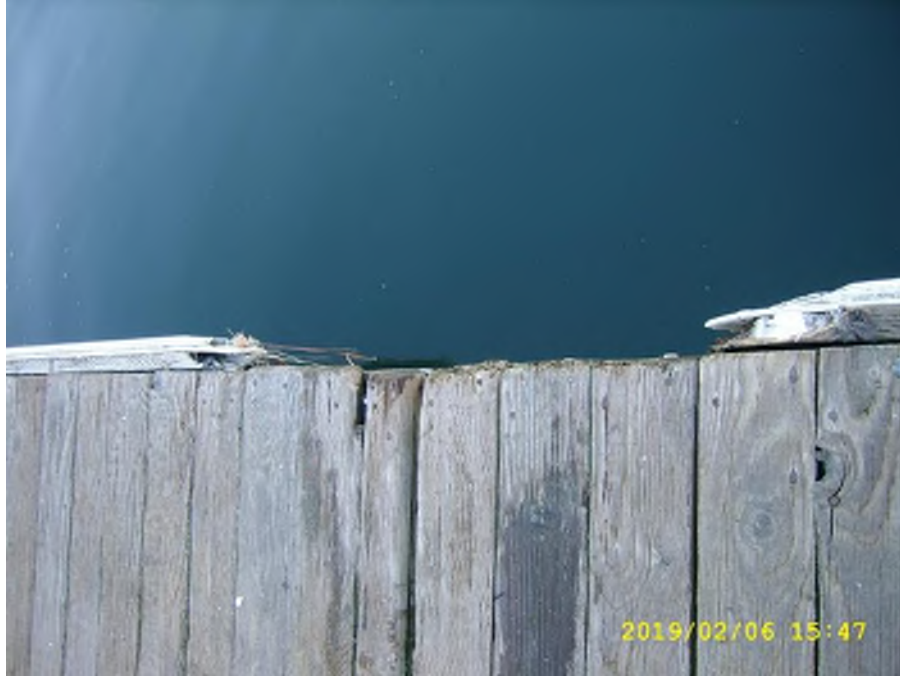
Figure 51. Boat Launch – Typical Rub Board and Bumper Damage

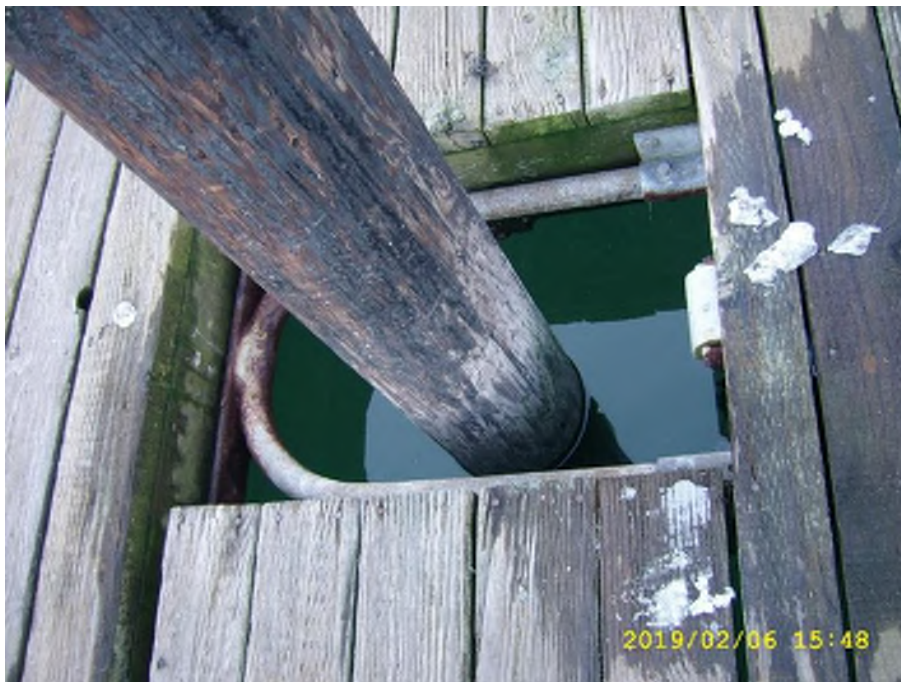
Figure 52. Boat Launch – Typical Timber Pile Condition

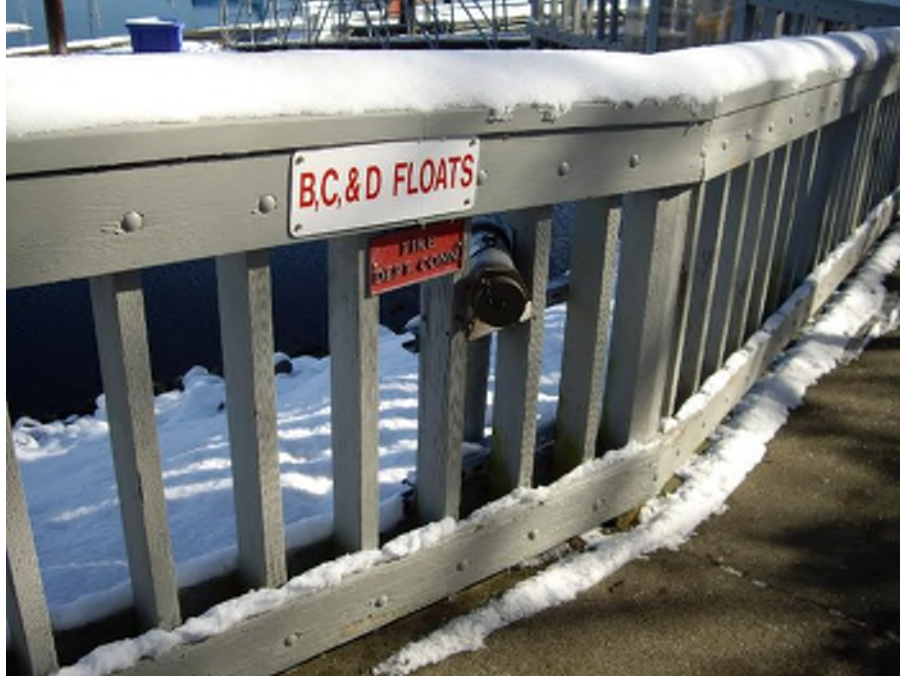
Figure 53. Marina Utilities – Typical Fire Department Connection

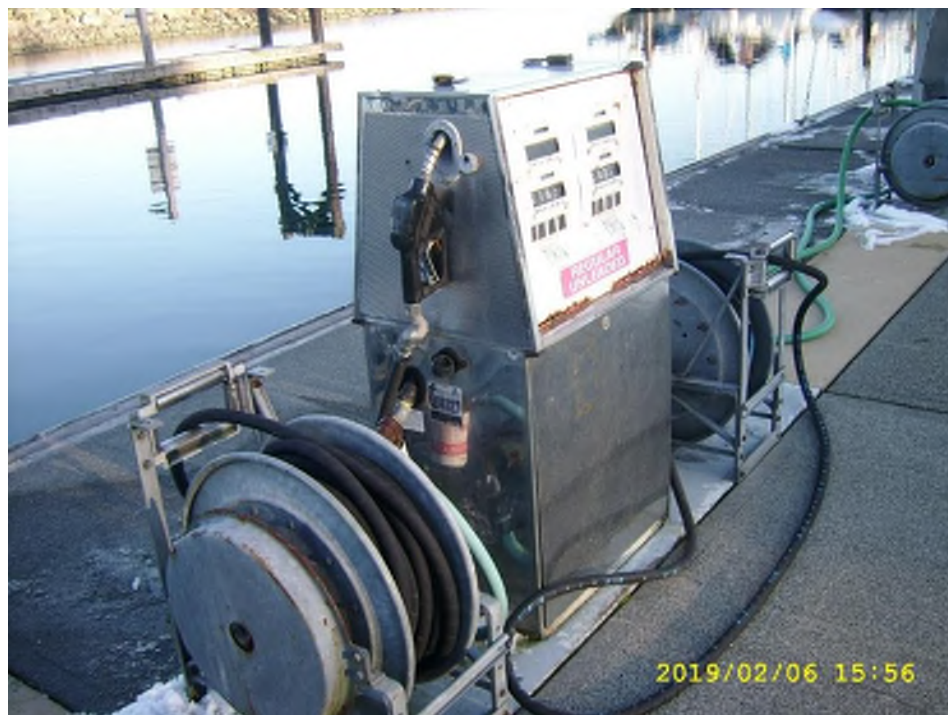
Figure 56. Marina Utilities – Typical Fuel Pump Condition

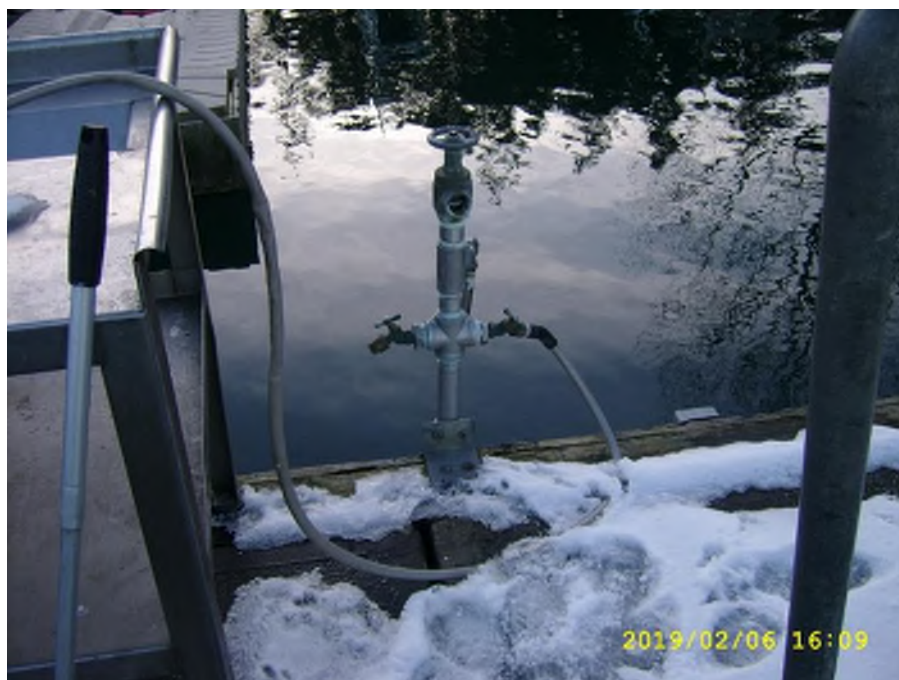
Figure 57. Marina Utilities – Typical Hose Bib Condition

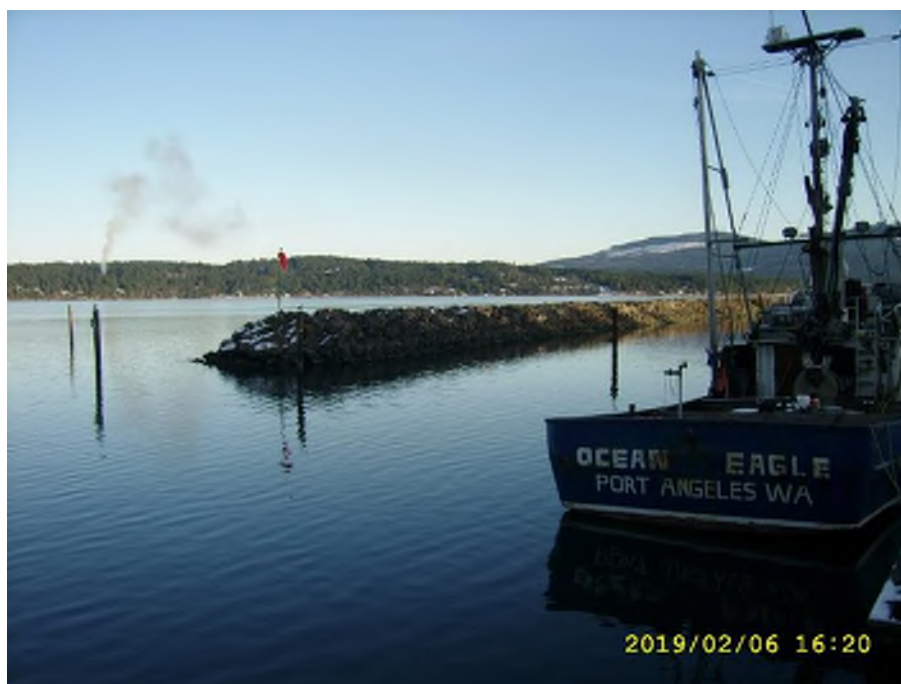
Figure 58. Breakwater – Typical Rip Rap

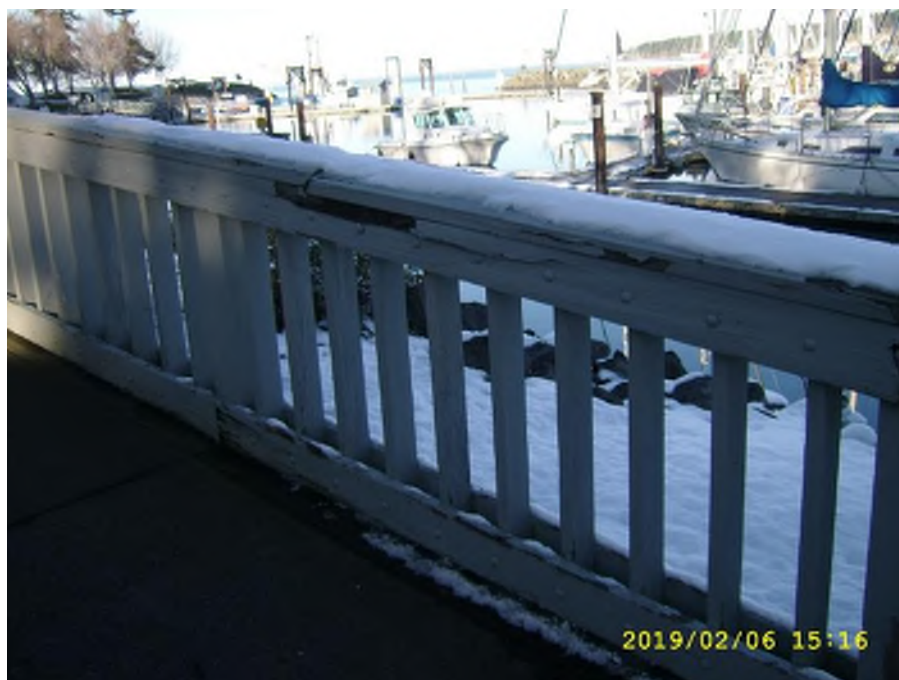
Guardrail	60, 61	Fair	The timber guardrail is in fair condition overall with moderate deterioration of the timber members. Approximately 25 percent of the timbers are damaged.
Upland Utilities	62	Satisfactory to Fair	<p>Fire water services upland were not visible other than the fire hydrants, which appear in satisfactory condition. According to available record drawings, an 8-inch ductile iron water line was installed in 1984. Based on age, it is likely in satisfactory to fair condition.</p> <p>Potable water services upland were not visible. According to available record drawings, a 3-inch PVC water line was installed in 1984. Based on age, it is likely in fair condition.</p> <p>Sanitary sewer utilities upland were not visible. According to available record drawings, a 6-inch line, septic tanks, and lift station and pump to the drain field were installed in 1984. Based on age, the</p>

Figure 61. Guardrail – Typical Timber Guardrail Damage / Deterioration

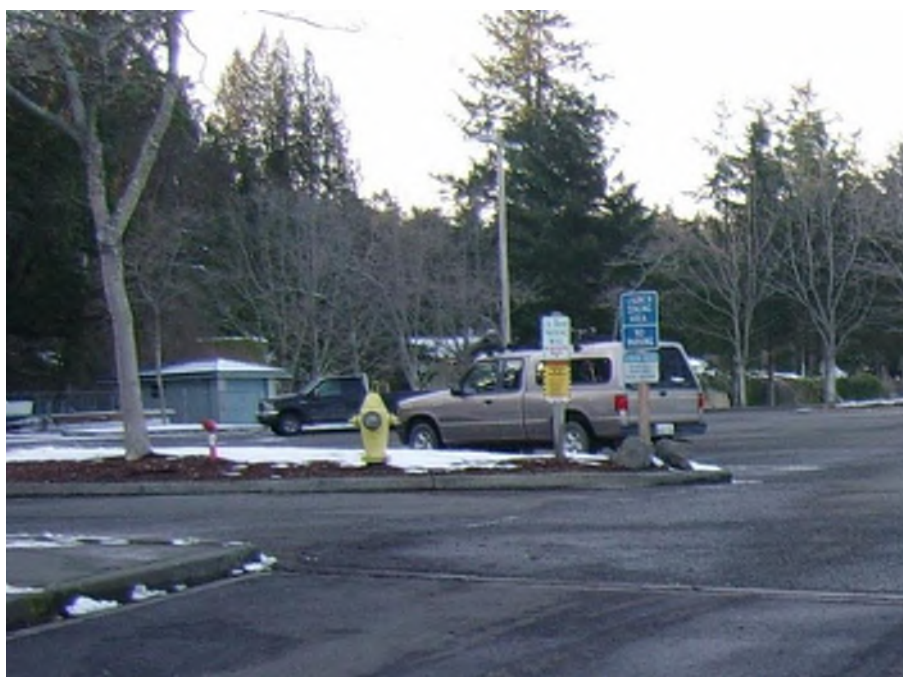
Figure 62. Upland Utilities – Fire Hydrant

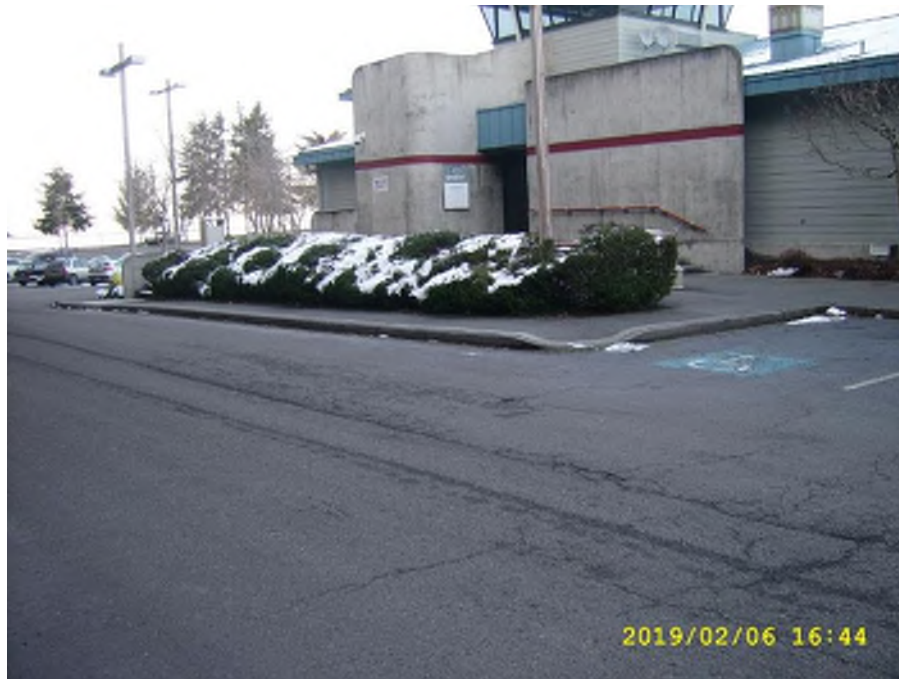
Figure 65. Site Paving – Typical Cracked Pavement

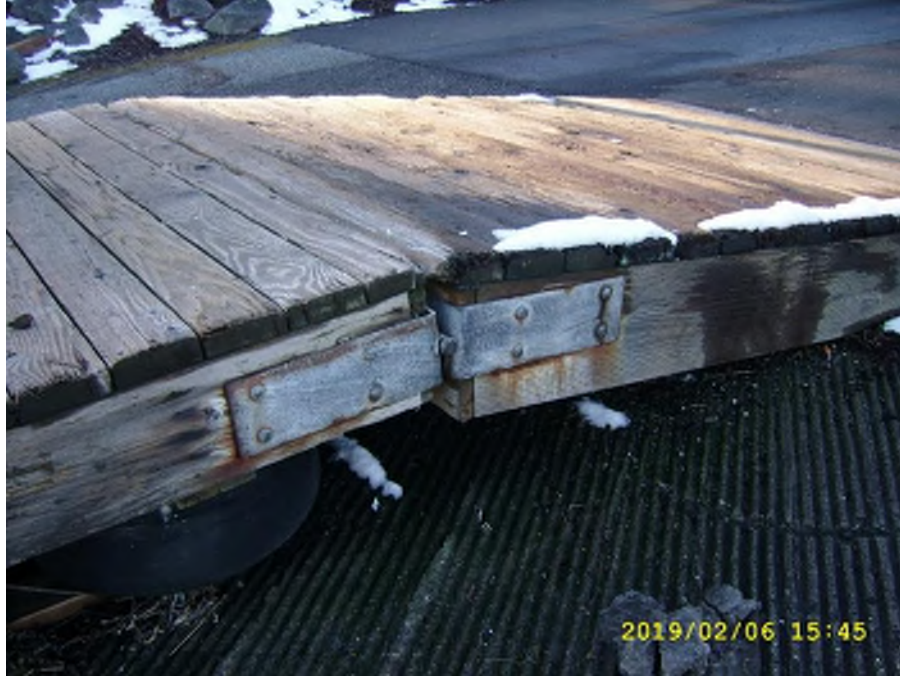
Figure 47. Boat Launch – Typical Worn Timber Decking and End Rot.
